Case no: Svk 2023/1561

The disruption on April 26, 2023

Description of the sequence of events of the disturbance

Swedish power grid

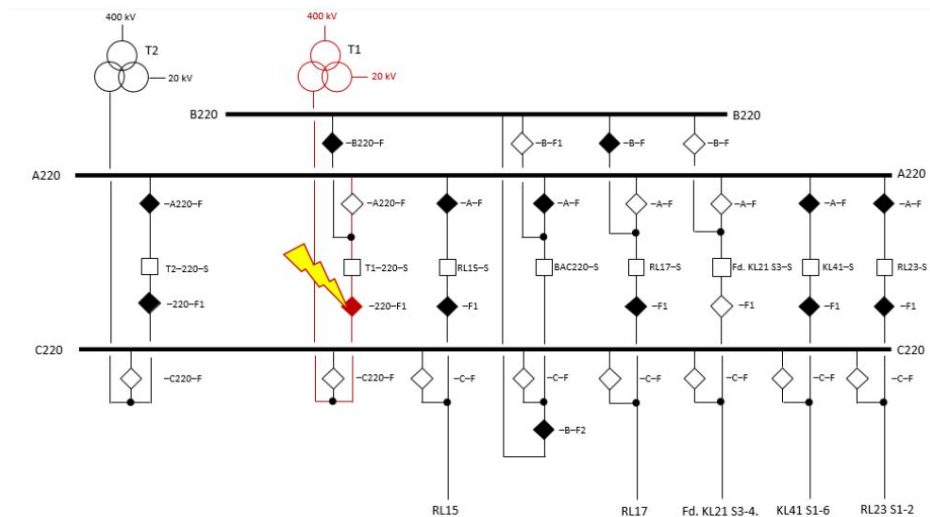
In connection with the planned maintenance work in the switchgear in Hagby, a 220 kV disconnector with continuous operating current was opened. Disconnectors are not made for this and an arc occurred. This resulted in a fault current in two phases which later develops into a fault current in all three phases. Forsmark 1 and 2 were disconnected from the 400 kV grid due to undervoltage after approx. 1 second, shortly after that the generator breakers are disconnected. The primary fault in Hagby is only disconnected after about 7 seconds, which leads to very low operating voltages in the transmission and distribution networks in the region during the fault period. A more detailed description of the course of events follows.

Figure 3. The commissioning diagram for the 220 kV switchgear in Hagby where the short circuit that occurred at the connections is marked with a flash.

The short circuit meant that both 220 kV busbar protectors tripped momentarily in CT65 Hagby and tripped all 220 kV circuit breakers. This is correct because the busbar protectors are measuring on T1-220-IT, which sits in T1's bushing, which meant the fault was in the measuring zone. However, the fault was not disconnected when the T1-220-S was switched off because there was still a fault current input from the 400 kV mains through the T1's 400 kV compartment. Due to two independent failures in the control system, the T1-400-FS did not disconnect until approximately 7 seconds later. Troubleshooting in Hagby after the disturbance has revealed a design flaw in the protection system of Sub 1 as well as a fault in the tripping circuit of Sub 2, which may explain the initial failure to trip the T1-400-FS. The primary fault was disconnected by T1's zero voltage automatic.

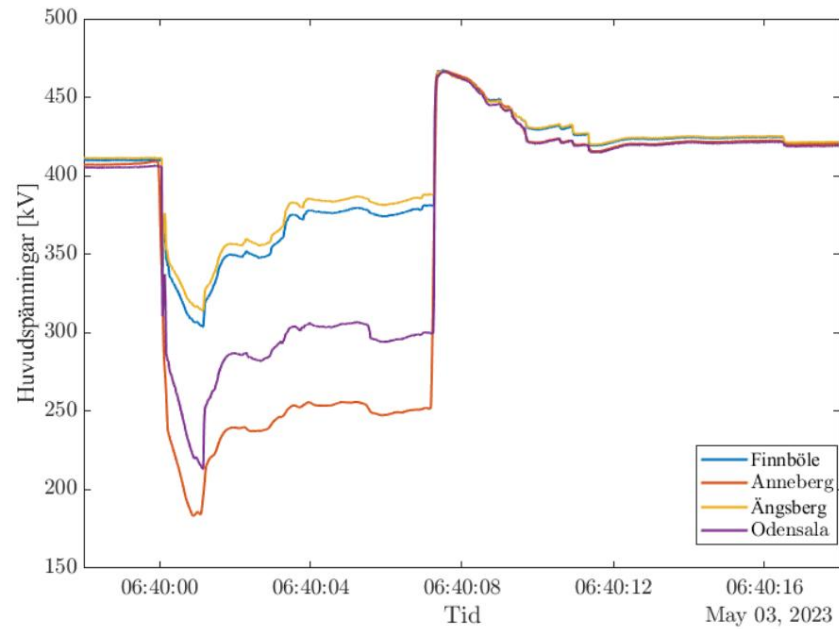
High fault currents during the operational disruption in Hagby contributed to a sharp voltage drop in the electrical vicinity. Due to the extent of the error, a clear impact on other more distant stations could also be identified. Figure 4 shows the voltage development during the sequence of events for some nearby stations. The fault current lasted for about 7 seconds until the fault could be completely disconnected. After disconnection of the fault, the voltage increased sharply, up to about 465 kV, for a number of seconds before magnetizing systems of remaining generating facilities were able to restore the voltage to a level closer to the normal voltage range.

Figure 4. Measured main voltages (positive sequence) in stations in the electrical vicinity of Hagby.

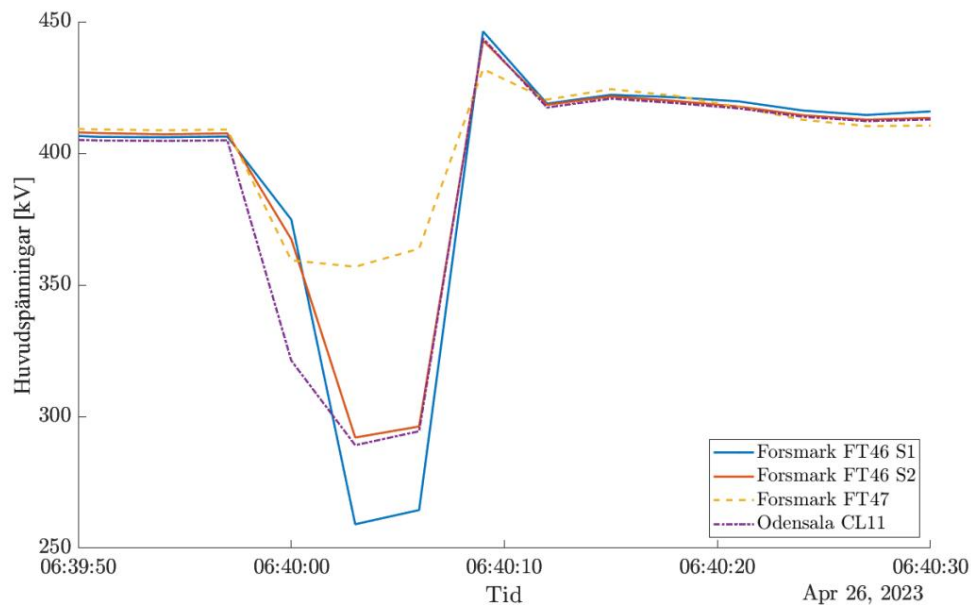
High-resolution voltage measurements during *the entire* disturbance sequence are missing for the stations Forsmark FT46 and Forsmark FT47, but by analyzing measurement values from the ALBA/energy meter system², an approximate picture of the voltages during the sequence of events is obtained, which is shown in Figure 5. Preliminary analyzes of the data from the disturbance recorders show, however, that the voltage increase after the fault disconnection probably was significantly higher, closer to 470 kV, than shown in Figure 5.

Figure 5. Principal stresses in Forsmark FT46 S1/S2, Forsmark FT47 (as well as Odensala as a reference) with measurements from the ALBA system.

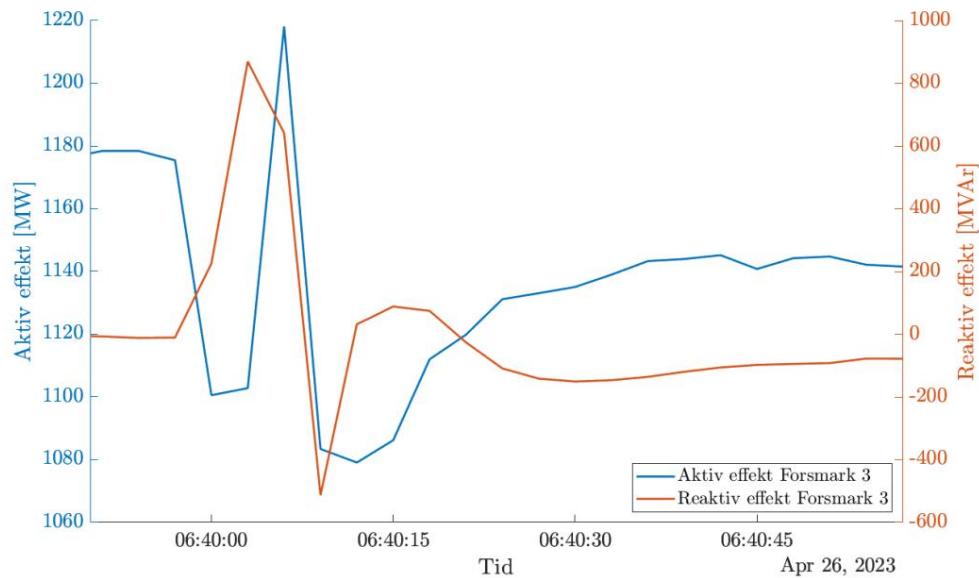
Figure 6 shows the active and reactive power output from Forsmark 3 during, and a few seconds after, the operational disruption in Hagby. As high-resolution data is missing for stations Forsmark FT46 and Forsmark FT47, ALBA data is used and despite a relatively low time resolution, the production of reactive power during the fault, as well as the consumption of reactive power after the fault has been disconnected, can still be clearly observed. During the outage, the reactive power generator contributed up to 870 Mvar to the grid, which supported the system voltage. After the fault in Hagby had been disconnected, the voltage was momentarily raised in the grid, causing the magnetizing system to instead work to lower the voltage. The generator then consumed reactive power down to 500 Mvar whereupon a few seconds later it returned to a similar level as before the malfunction.

Figure 6. Active and reactive power in Forsmark 3 during the operational disruption.

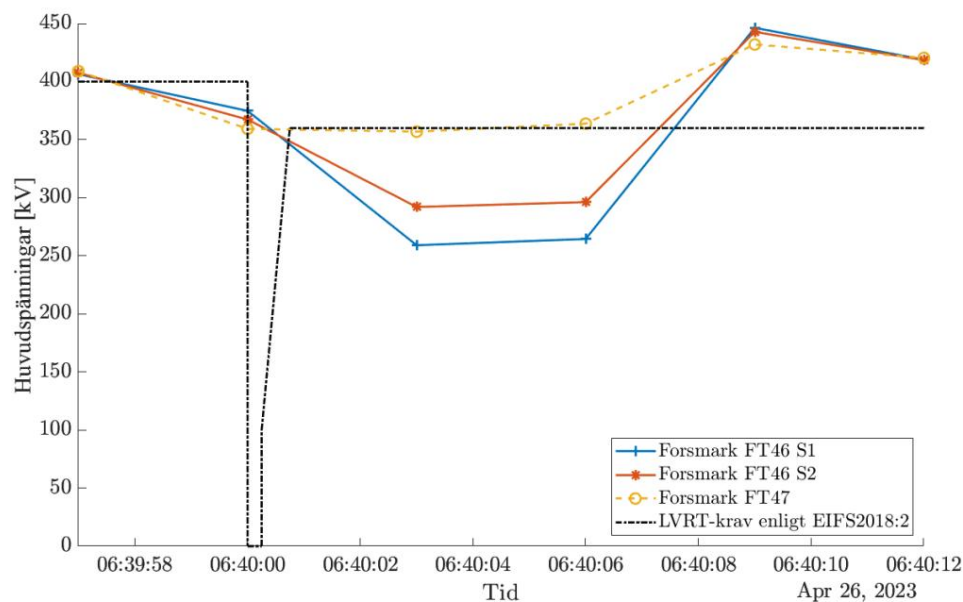
Forsmark 3 was able, despite a major impact on the system voltage in the station in question, to maintain its connection to the grid. High-resolution measurements are missing in the station, which is why ALBA data has been used to analyze the course of the disturbance. In Figure 7, the voltages in the stations Forsmark FT46 S1/S2 and Forsmark FT47 are shown together with the requirements for resistance to disturbances with respect to voltage levels over time (LVRT) according to SvKFS 2005:2. It is established that the voltages in the Forsmark FT47 were *very close* to the required voltage profile for the plant to be kept connected to the grid. In Figure 7, it can also be read that the measured voltages in Forsmark FT46 S1/S2 are significantly below the voltages that are required for interference resistance in SvKFS 2005:2.

Figure 7. Voltages in Forsmark FT46 S1/S2 and Forsmark FT47 and LVRT requirements according to SvKFS 2005:2.

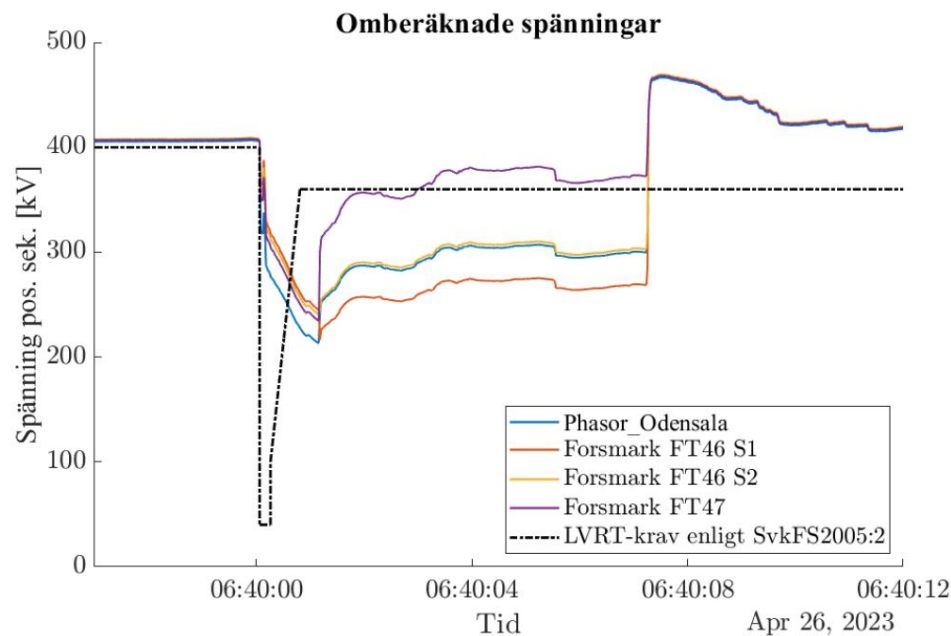
By correlating and recalculating voltages from PMU measurement in Odensala against ALBA data from Forsmark FT46 S1/S2 and Forsmark FT47, an estimate of how the voltages in these stations looked during the disruption can be estimated, which is shown in Figure 8. The figure shows that the voltage levels for the Forsmark FT47 may have been *below* the interference tolerance requirements for 2 seconds after the fault occurred. However, these results are associated with uncertainty

Figure 8. Recalculated and estimated voltages (positive sequence) Forsmark FT46 S1/S2 and Forsmark FT47 and LVRT requirements according to SvFS 2005:2.

The relatively large difference in voltage levels between the stations Forsmark FT46 S1/S2 and Forsmark FT47 was due to the current network topology.

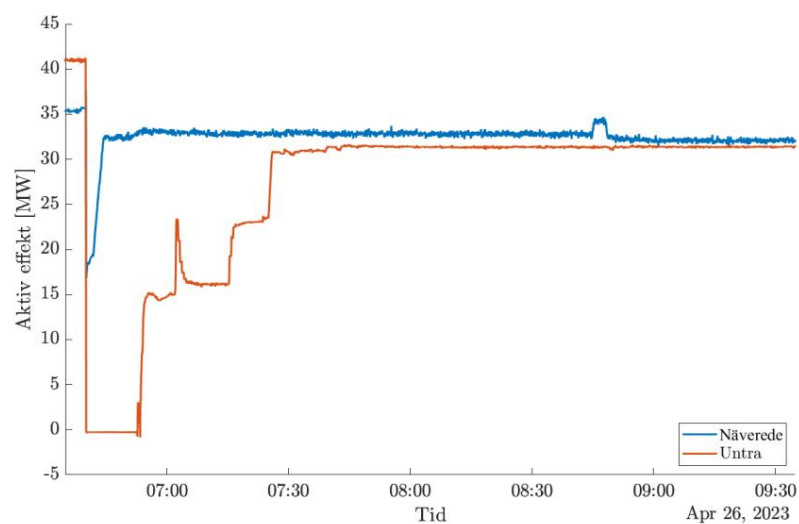
Figure 9 shows the active effect during and a couple of hours after the operational disruption in Hagby for a number of production plants where measurement data from the ALBA system was available. A major impact can be identified on the Untra power plant, which was completely disconnected from the grid for a number of minutes. A gradual reconnection to the network can then be seen during the following 30 minutes. Production, which is geographically and electrically weakly connected to the station in Hagby, was also affected by the disruption. The hydroelectric power plant in Näverede, in SE2, was initially affected by the disruption, but the production level was restored within a couple of minutes.

**Figure 9.** Active power for Näverede's hydropower plant and Untra's power plant.

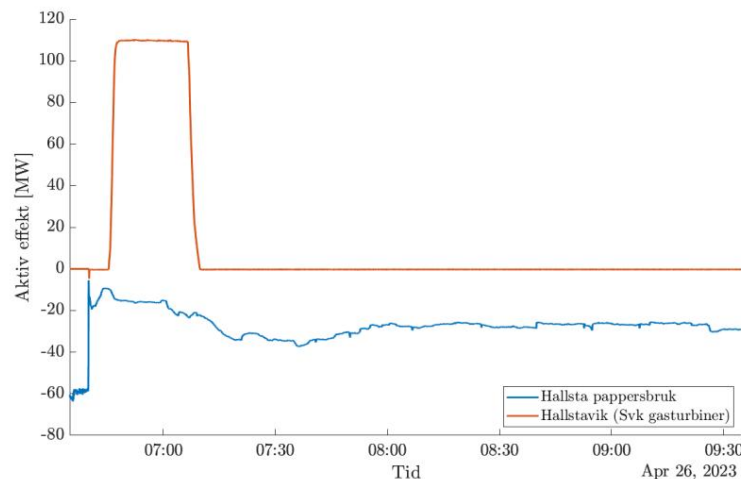
Figure 10 shows the activation of the gas turbines a few minutes after the malfunction occurred. At the same time, a relatively clear reduction in the load at Hallsta Pappersbruk can be identified, which has probably stabilized the network. The load is then partially recovered after the fault has been disconnected.

Figure 10. Active power for Hallsta paper mill and Svk gas turbines Hallstavik.

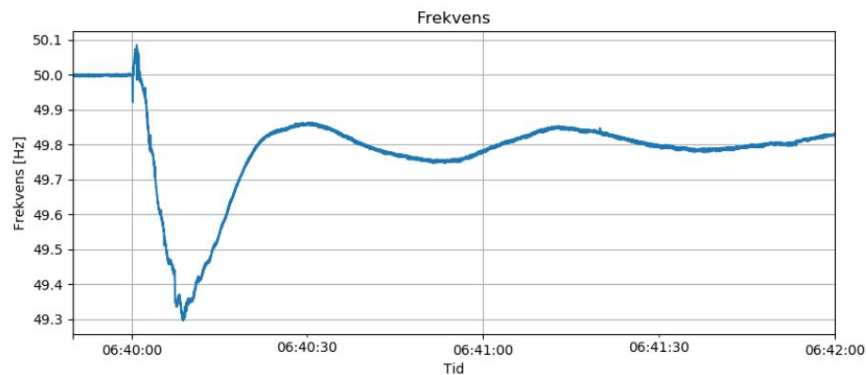
From the time the protection tripped the first transformer in Forsmark FT46 until both Forsmark 1 and 2 were disconnected, it took about 0.5 seconds. This meant that a sudden difference between production and consumption arose, which had a direct impact on the frequency in the Nordic synchronous area. Figure 11 illustrates how the frequency dropped quickly in connection with the operational disturbance, the lowest frequency was measured at 49.3 Hz and occurred approx. 8 seconds after the disconnection of Forsmark 1 and 2.

Figure 11. Measured frequency in the Nordic synchronous area in connection with the disturbance on 26 April. The frequency measurement is from station Hallsberg.

At the beginning of the disturbance process, when the voltages were very low but before Forsmark 1 and 2 had been disconnected, the frequency increased, see Figure 11. This frequency increase seems to indicate that the consumption was reduced initially due to the low voltage that occurred. Parts of the consumption in the power system are voltage dependent, the consumption decreases when the voltage drops.

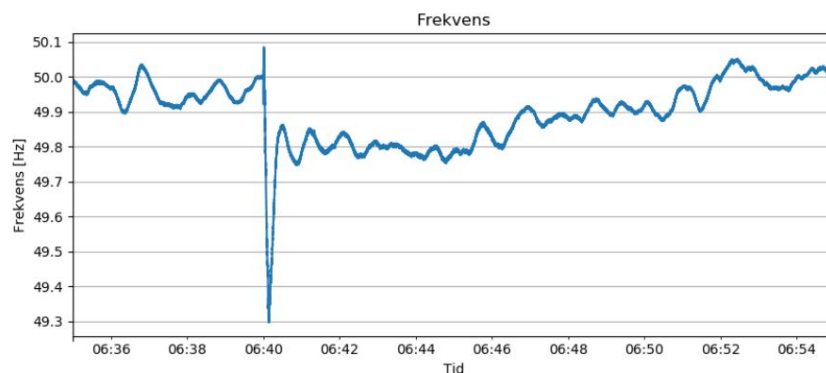
After the frequency dip, the frequency remained outside the range of continuous normal operation (49.90-50.10 Hz) for 7 minutes. The frequency stabilized above 49.90 Hz after about 12 minutes, see Figure 12.

Figure 12. The frequency in the Nordic synchronous area during and after the disruption.

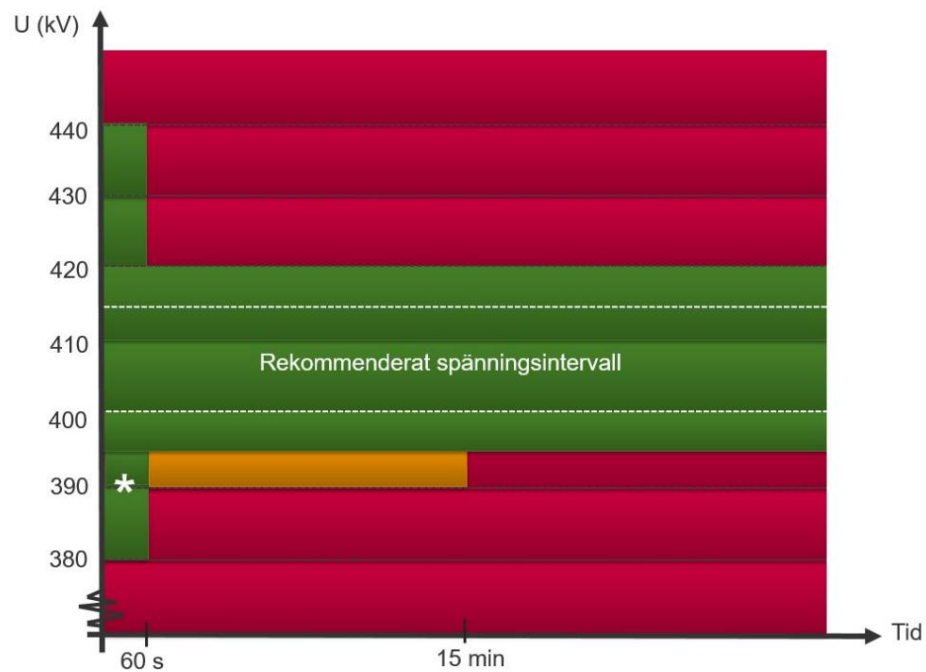
The fault in Hagby caused a severe voltage drop and a voltage increase when the fault was disconnected, in total the power system was in the emergency mode for 9 seconds. The limit value for each operating condition with regard to voltage is shown in Figure 13.

Figure 13. System operating conditions for voltage.

In connection with the failure, a voltage of 183 kV was measured in Anneberg (400 kV), the low voltage lasted for 7 seconds. The lower limit for emergency operation is 380 kV, so the power system was in emergency operation due to low voltages for 7 seconds. The voltages in other stations, see 4.1.

After the disconnection of the fault, the voltage in several stations increased to about 465 kV, the high voltage lasted for 2 seconds. The upper limit for emergency operation is 440 kV, so the system was in emergency operation due to high voltages for 2 seconds.

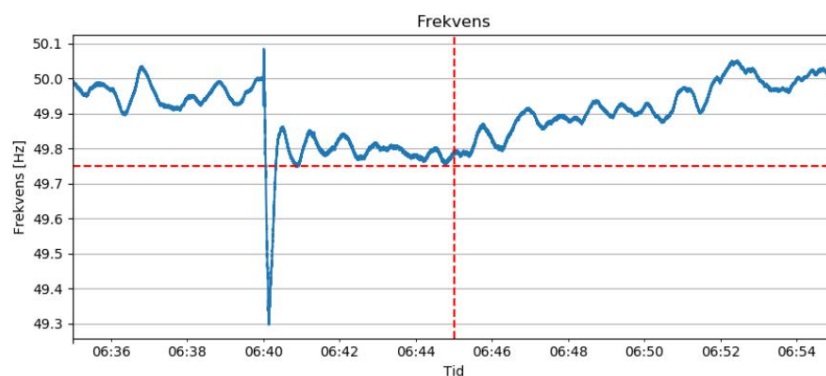
In order not to fall outside normal operation, the frequency must be above 49.75 Hz after 5 minutes from the start of the disturbance. Support lines have been drawn in Figure 15 together with the frequency measurement.

Figure 15. The frequency in the Nordic synchronous area during and after the disturbance on April 26 and support lines in red showing that the frequency was not below 49.75 Hz for more than 5 minutes.
