DISTURBANCE INVOLVING THE NORTHERN INTERCONNECTIONS NORTHEAST, SOUTH-EAST-NORTH-EAST AND NORTH-SOUTH-EAST

Disturbance on 08/15/2023 at 8:30 am involving the N/SE, N/NE and SE/NE interconnections

Analysis of the restoration process

RAP meeting - 08/25/2023

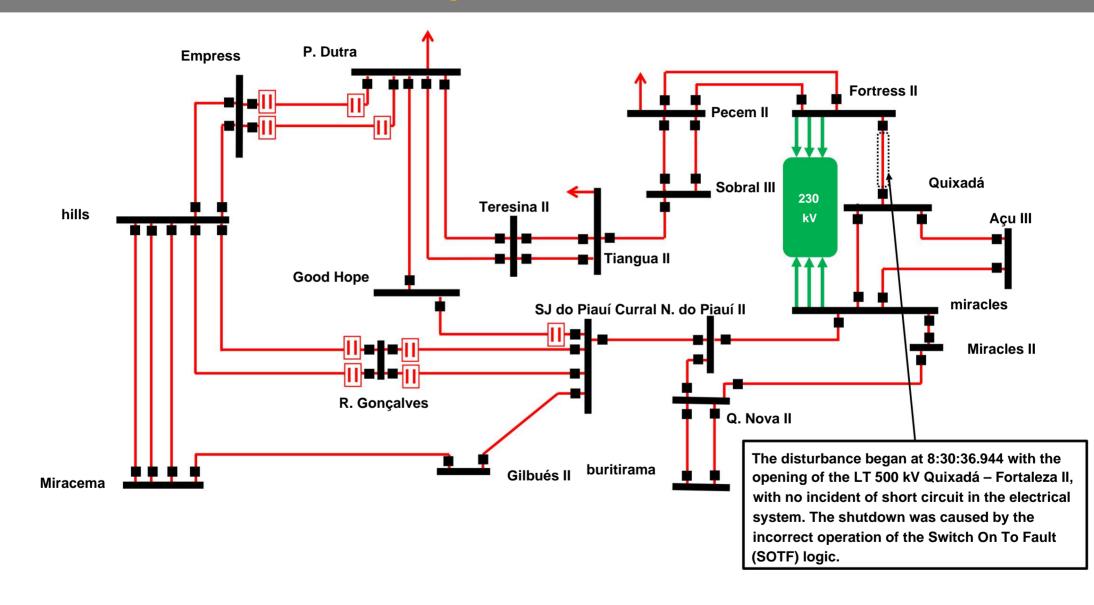
Shutdown of LT 500 kV Quixadá – Fortaleza II

- The opening of the LT 500 kV Quixadá Fortaleza II was caused by the incorrect operation of the fault closing protection (Switch Onto Fault - SOTF) during normal line operation. It was also observed the improper performance of its scheme automatic reclosing.

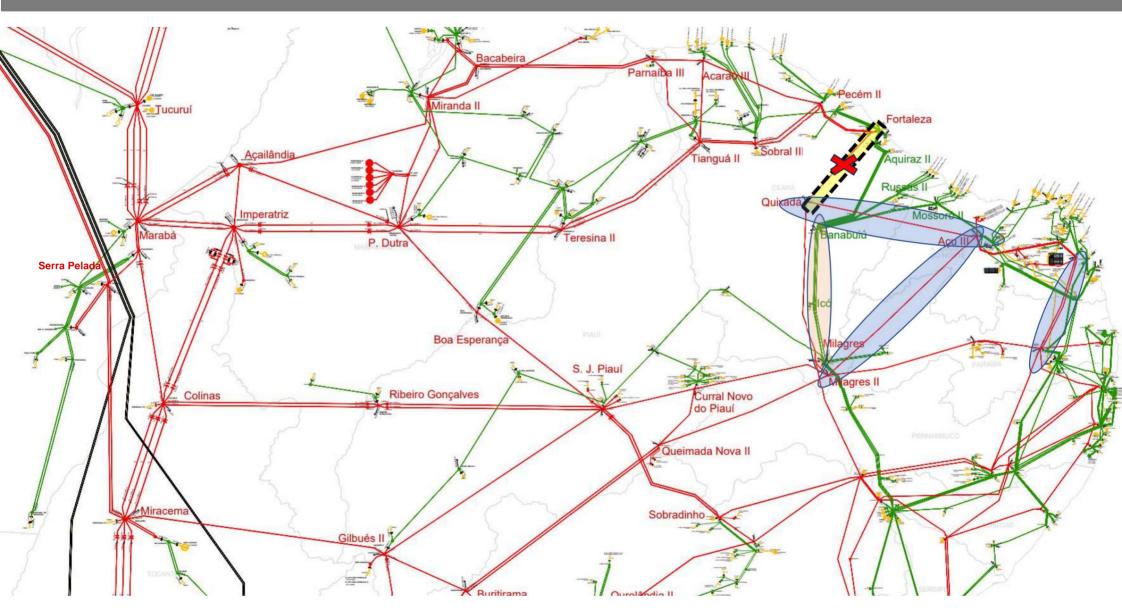
SIN Dynamic Performance – Opening P. Dutra – Boa Esperança (PPS Performance)

- The opening of the LT 500 kV Quixadá Fortaleza II caused a significant reduction of tension in the system, resulting in the opening of LT 500 kV Presidente Dutra Boa Esperança for actuating the out-of-sync protection (PPS), which also commands the opening of the LT 500 kV Presidente Dutra Teresina II C1 and C2 and LT 500 kV Presidente Dutra Imperatriz C2 lines.

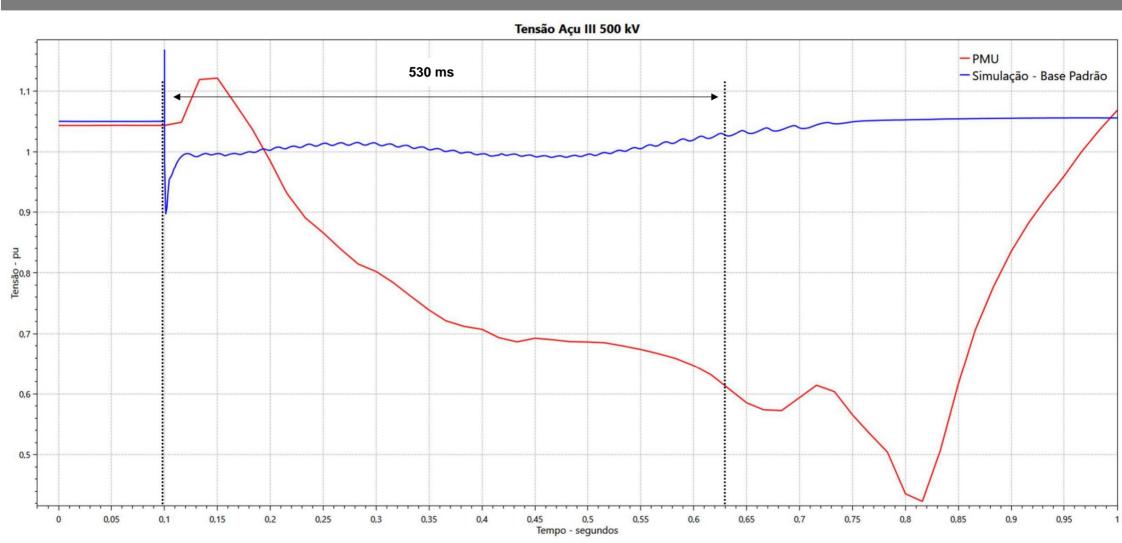
Simulation with official database x PMU registration

- The voltage reduction observed after the opening of the LT 500 kV Quixadá Fortaleza II was not verified in the simulations carried out by the ONS to reproduce the disturbance of 08/15/2023, using the real-time steady state case and the official electromechanical transient database, based on information provided by agents.

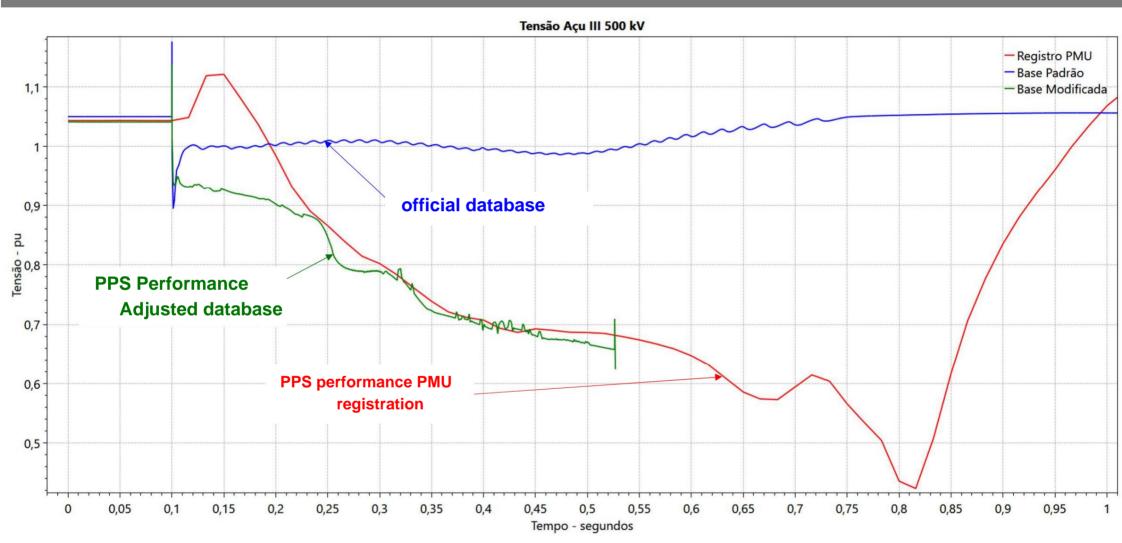
Official Base x PMU Register x Adjusted Electromechanical Transients Database

- The voltage observed in SE 500 kV Açu III is an indication that the adjusted models are more adherent to the field.
- Simulation for comparison with oscillography records

- The most consistent line of investigation points to this performance below expectations as a second
 event that triggered the entire subsequent transmission line shutdown process, the ONS
 was able to satisfactorily reproduce the disturbance by changing the transient database
 electromechanical, highlighting a possible difference between the behavior of equipment controls
 effectively implemented in the field and the performance of the mathematical models made available to the ONS.

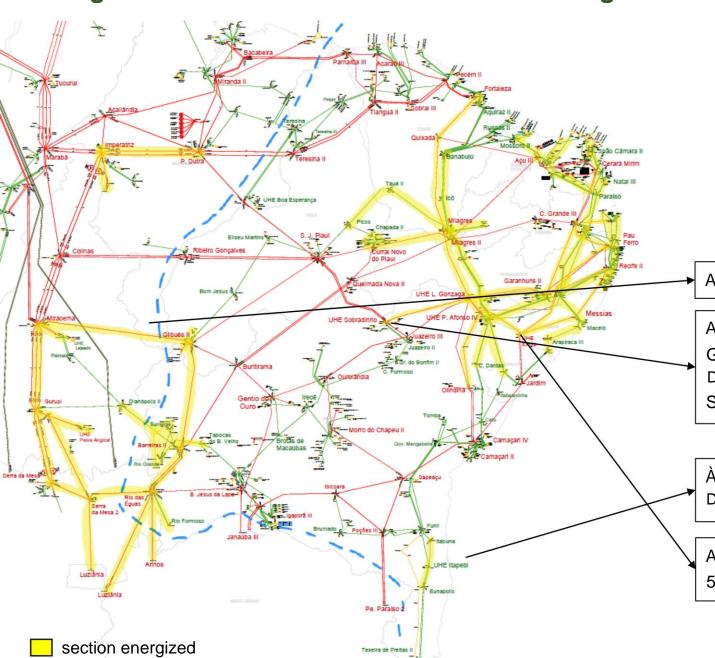
Machine Translated by Google Configuration at 09:41 – UHE Sobradinho energized

Difficulty in self-healing at the UHE Sobradinho.

Às 09h41, syncronizada a 2ª UG na UHE Itapebi – Difficulty synchronizing.

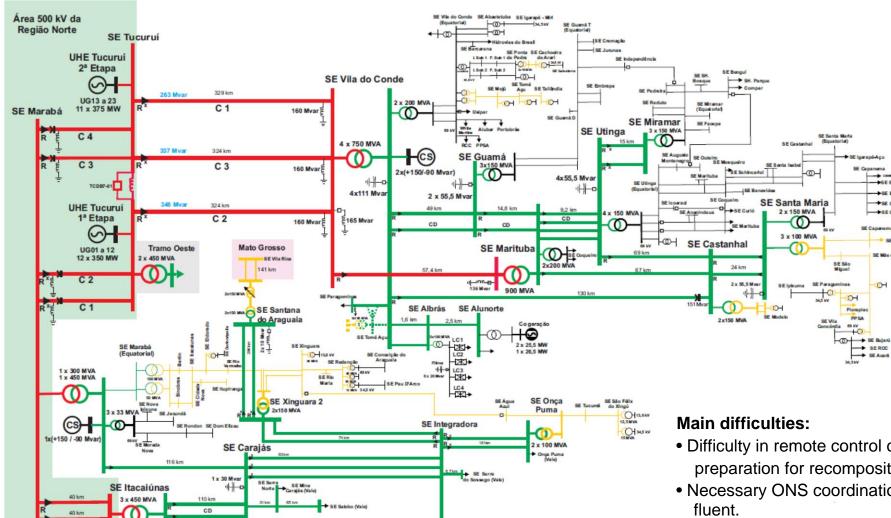
Tucuruí / Pará Area

- Difficulty in remote control of equipment, compromising the preparation for recomposition.
- Necessary ONS coordination in practically the entire phase fluent.
- Facilities were not prepared for rebuilding.
- UHE Tucuruí did not assume frequency control, as per set out in the instructions.

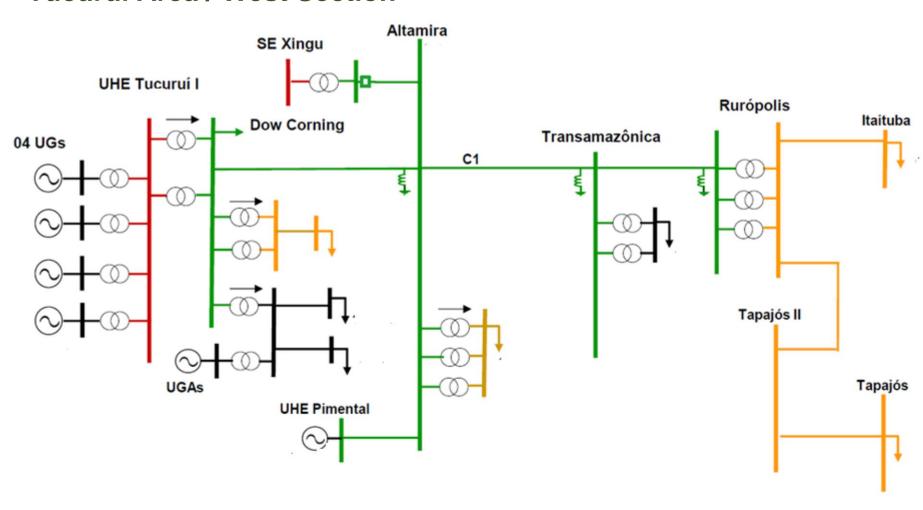
Tucuruí Area / West Section

At 12:47 pm there was a partial loss of reestablished loads, around 63%, due to the shutdown automatic 138 kV bus SE Rurópolis. The restoration of loads returned at 12:59 pm following normally until the end of the restoration. At 1:50 pm, COSR-NCO authorized the full restoration of loads from Pará.

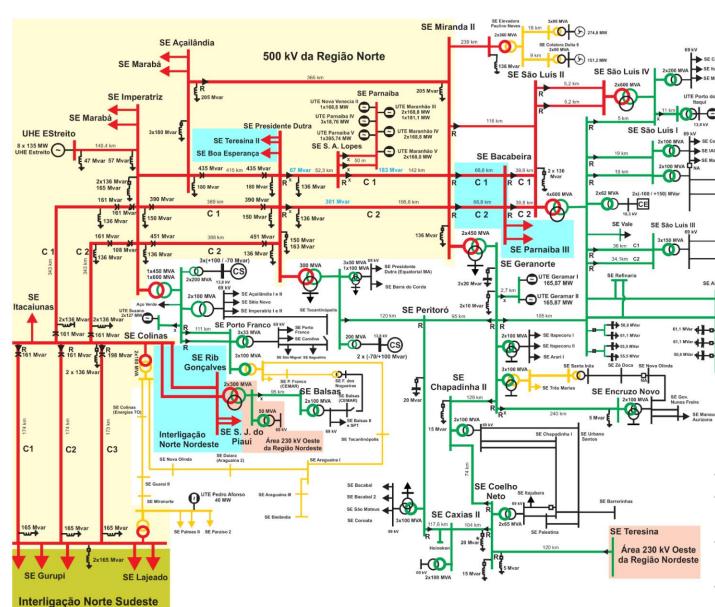
Area 500/230 kV Maranhão / Estreito

- Difficulty in resuming load.
- At 11:04 am, the Estreito HPP was shut down due to oscillation of frequency.
- ONS opted for carrying out a recomposition alternative, for the 230 kV of the SE P. Dutra.
- At 12:22 pm, the 1st GU at Estreito HPP was synchronized and elevation started generation to the programmed value. At 12:31 the plant reached programmed generation value.

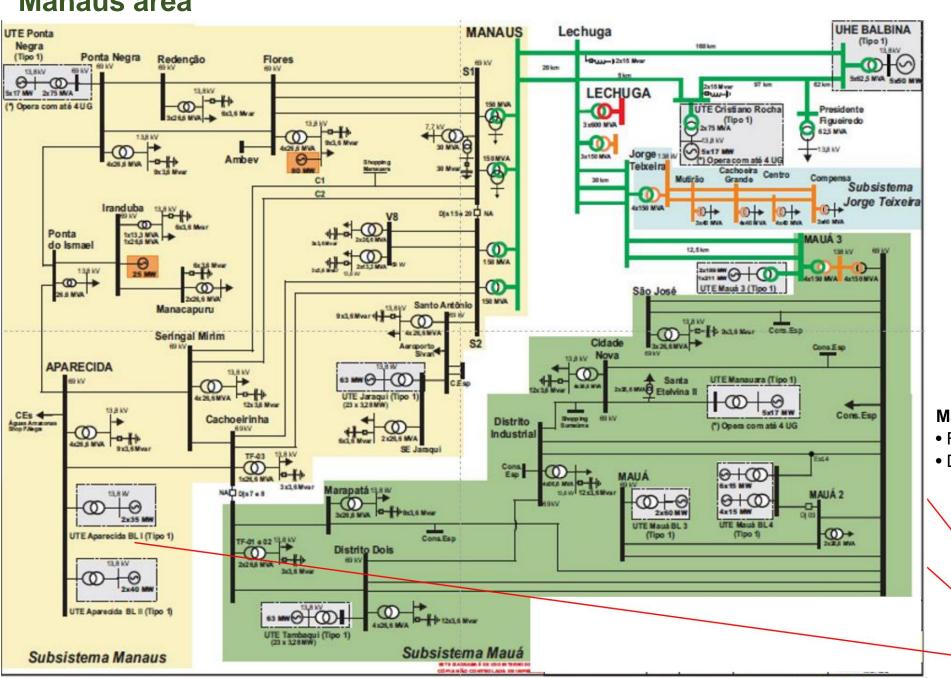
Manaus area

- Failure in communication channels.
- Delay in starting up thermal generation.

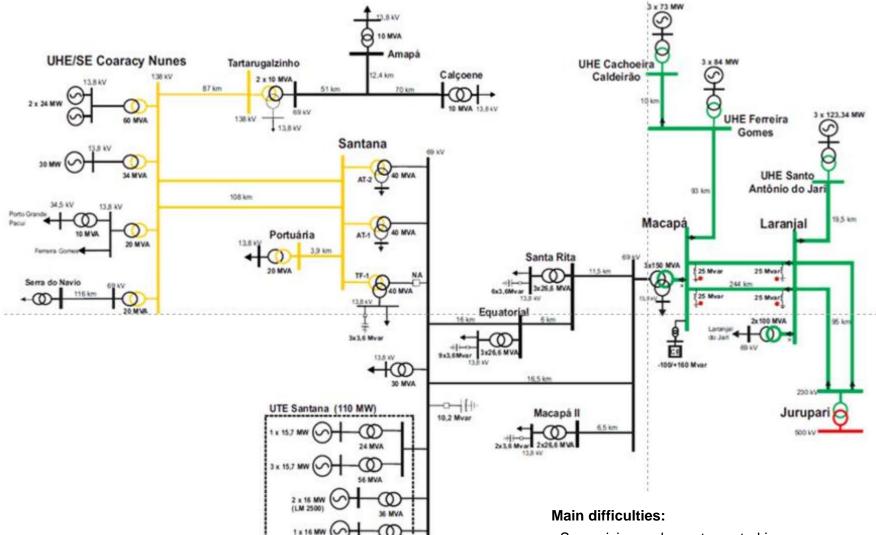
Amapá area

- Supervision and remote control issues.
- Loss of communication channel with the distribution company between 09:12 and 13:48.
- During the fluent recomposition process, 4 situations occurred that caused the beginning of recomposition.
- At the time of interconnection with the SIN, UHE Coaracy Nunes served 25 MW of load.
