Case no: Svk 2023/1561

The disruption on April 26, 2023

Description of the sequence of events of the disturbance

Swedish power grid

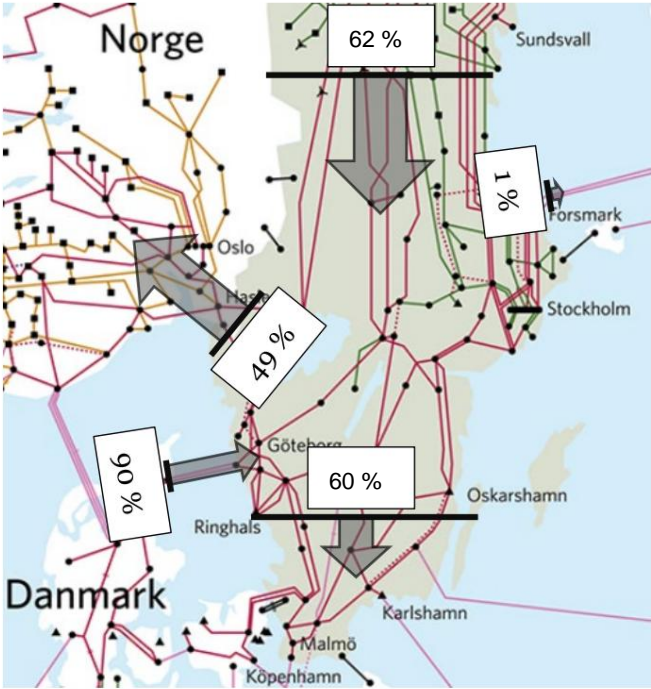
Before the disturbance occurred, transmission was moderate to/from electrical area SE3 (see Table 2). Section 2 and Section 4 utilized approx. 60% of allocated commercial capacity, which gave approx. 2,000 MW margin against the dimensioning N-1 error that the commercial capacity for those sections had been allocated based on. The transmission system was thus in normal operating condition. See Figure 1 for an overview of the flow pattern before the disturbance.

Figure 1. Overview of the flows to/from electricity area SE3 before the disturbance.

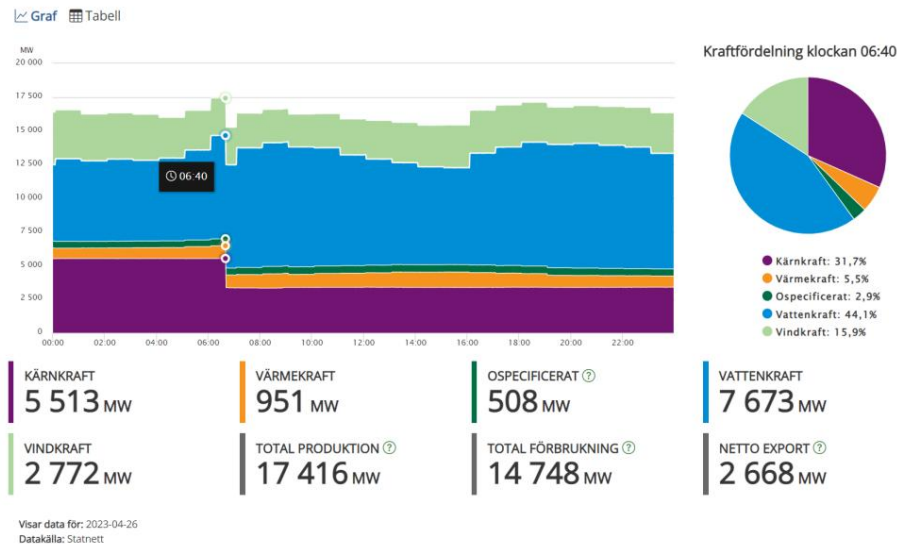
and wind power approx. 16%. Figure 2 shows the reported electricity production before the disturbance.¹

Figure 2. Shows the state of production according to the control room page on April 26, 2023 just before the disruption.

¹ **Figure 2** is taken from [the Control Room | Swedish power grid \(svk.se\)](https://svk.se). The figure shows the production situation just before the disruption. The reason why the corresponding image just after the disturbance is omitted is that this is not representative on the page because all the data is not updated synchronously. It is only around 08:00 as the data on the page reflects the actual state of production (when primarily hydro and exports have changed to cover the loss of nuclear generation).

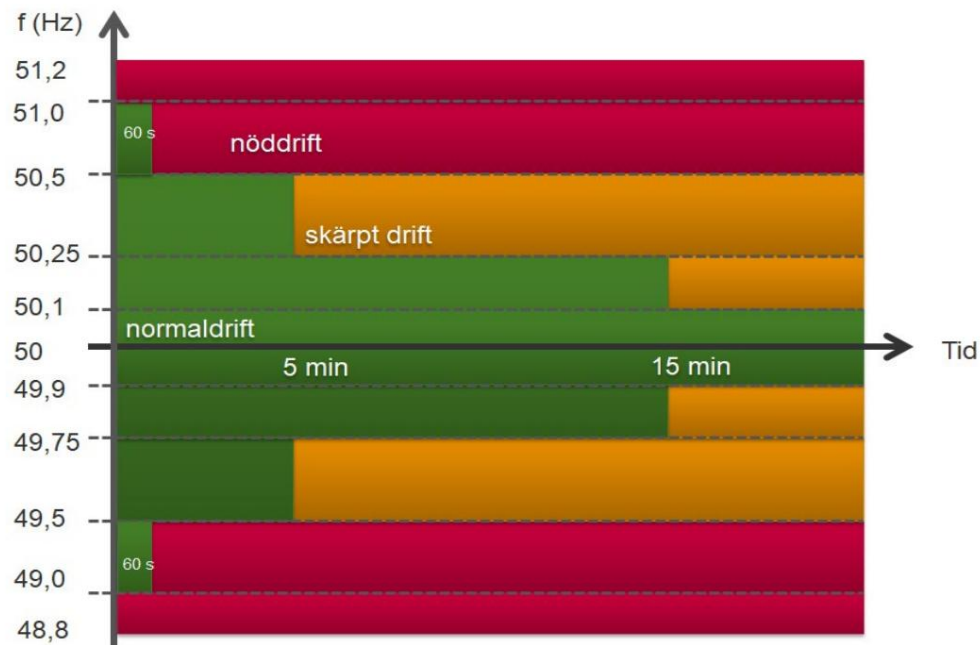
Throughout the course of the disturbance, the frequency was within the limits of normal operating conditions. Figure 14 illustrates the criteria for the frequency to be in normal, sharpened and emergency operation.

Figure 14. System operating conditions for frequency stability.

In order not to fall outside normal operation, the frequency must be above 49.75 Hz after 5 minutes from the start of the disturbance. Support lines have been drawn in Figure 15 together with the frequency measurement.
