DISTURBANCE INVOLVING THE NORTHERN INTERCONNECTIONS NORTHEAST, SOUTH-EAST-NORTH-EAST AND NORTH-SOUTH-EAST

Disturbance on 08/15/2023 at 8:30 am involving the N/SE, N/NE and SE/NE interconnections

Analysis of the restoration process

RAP meeting - 08/25/2023

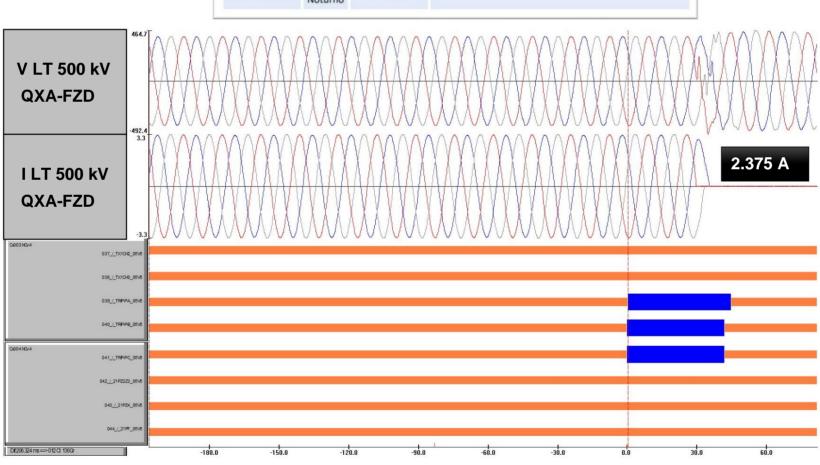
LT 500 kV Quixadá - Fortaleza

Shutdown of LT 500 kV Quixadá – Fortaleza II

- The opening of the LT 500 kV Quixadá Fortaleza II was caused by the incorrect operation of the fault closing protection (Switch Onto Fault - SOTF) during normal line operation. It was also observed the improper performance of its scheme automatic reclosing.

- The opening of the LT 500 kV Quixadá Fortaleza II caused a significant reduction of tension in the system, resulting in the opening of LT 500 kV Presidente Dutra Boa Esperança for actuating the out-of-sync protection (PPS), which also commands the opening of the LT 500 kV Presidente Dutra Teresina II C1 and C2 and LT 500 kV Presidente Dutra Imperatriz C2 lines.

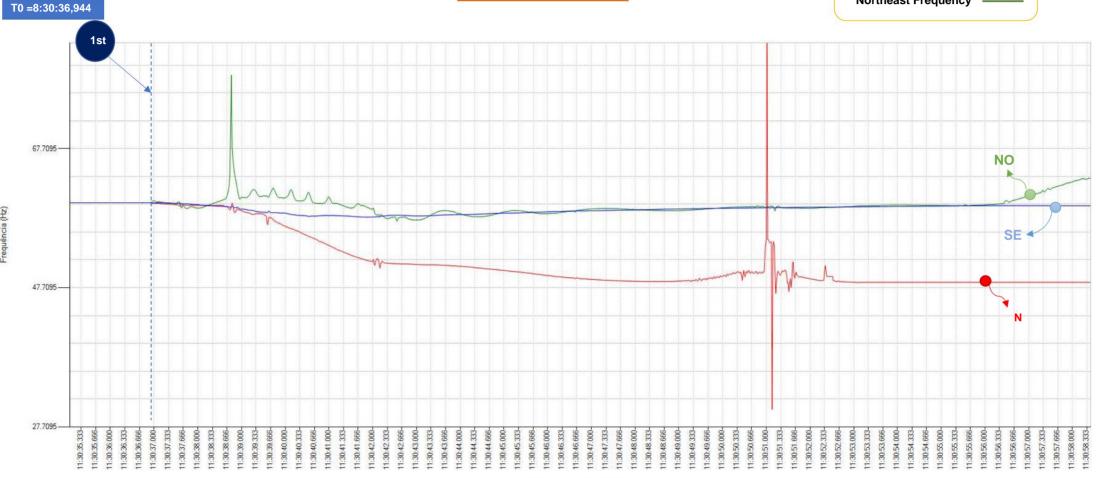
1st EVENT

North Frequency
Southeast Frequency
Northeast Frequency

Tempo (UTC) - Dia: 15/8/2023

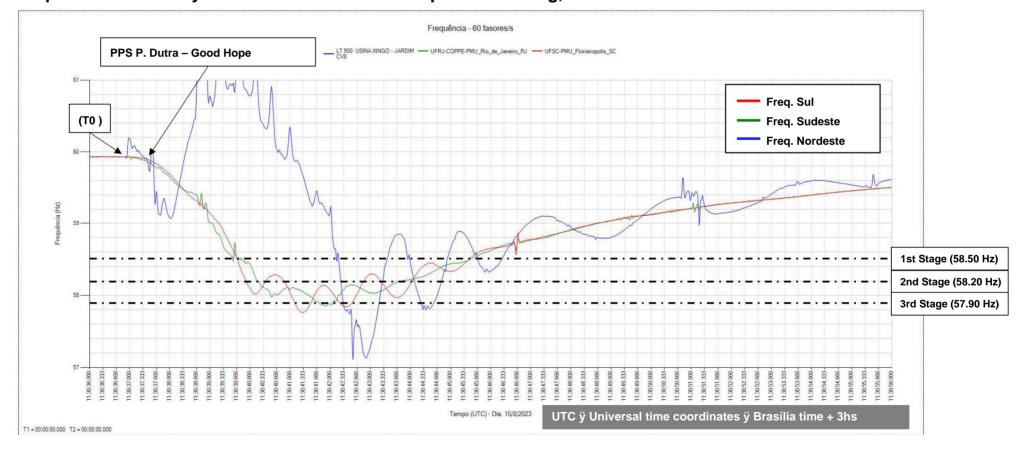
Satisfactory performance of the ERAC

- During the event, loss of generation was observed, based on the behavior of the frequency of the SIN. In this sense, in view of the generation deficit experienced by the SIN, the Regional Load Relief Scheme (ERAC) was implemented in order to promote the balance between load and generation.
- The ERAC performance analysis will be carried out in a specific meeting, to be held on 01/09.

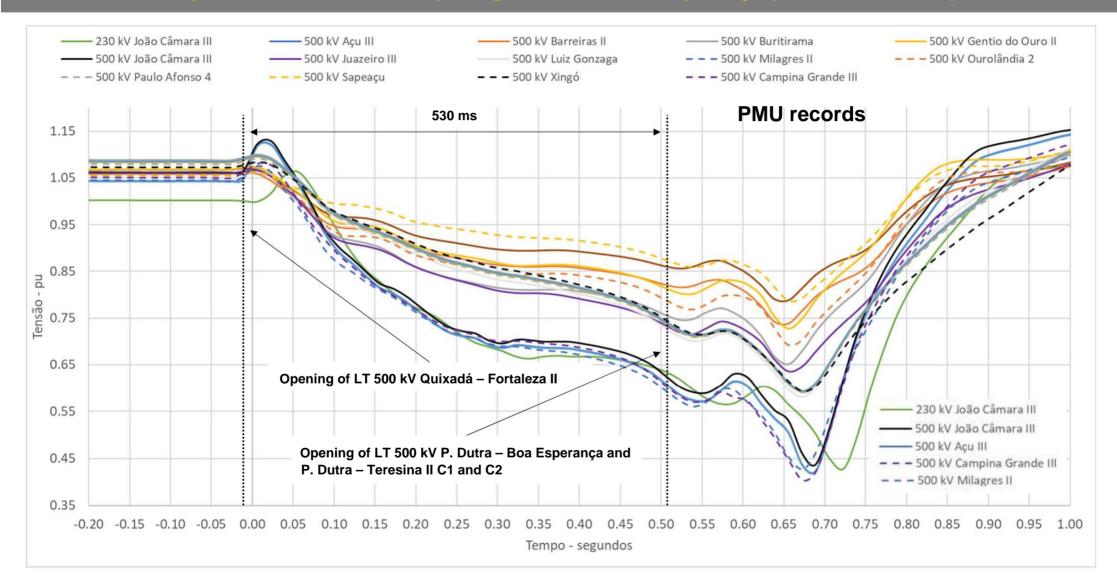
SIN Dynamic Performance – Opening P. Dutra – Boa Esperança (PPS Performance)

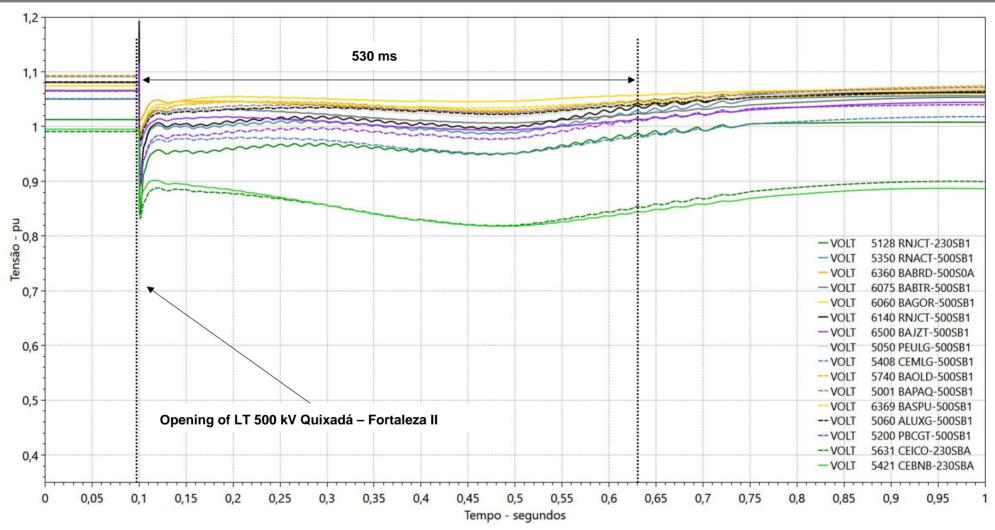
SIN Dynamic Performance - Event Simulation with Official Database (Real-time case)

- The voltage reduction observed after the opening of the LT 500 kV Quixadá Fortaleza II was not verified in the simulations carried out by the ONS to reproduce the disturbance of 08/15/2023, using the real-time steady state case and the official electromechanical transient database, based on information provided by agents.

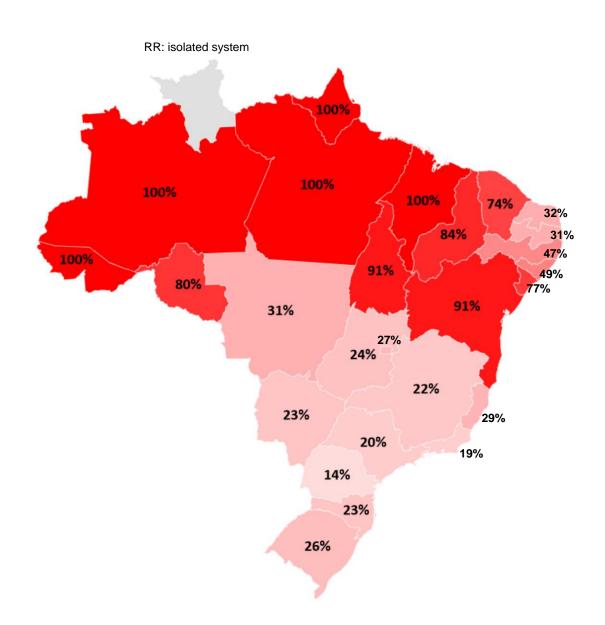
Load shedding by state

31% do SIN

99.5% of the North

South 20% from the Southeast/Midwest

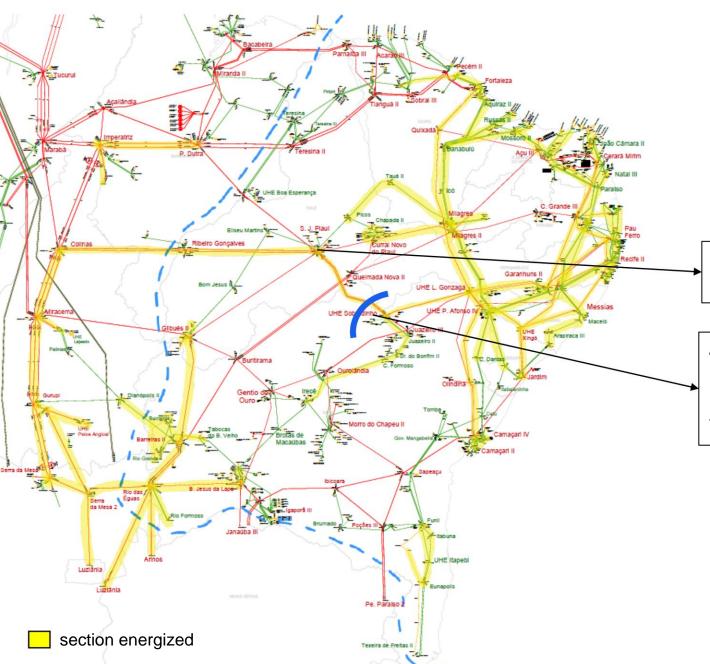
Machine Translated by Google Configuration at 10:50 am – Northeast integrated to the SIN

Service Conditions – 10:50 am		
hydroelectric	2.536	
Wind	3.060	
photovoltaic	687	
Thermal	110	
FNESE – (NE -> SE)	185	
FNEN – (NE -> N)	201	
NE load	6.007

At 10:32 am, the SE São João do Piauí received voltage from the SIN through the SE Ribeiro Gonçalves.

At 10:49 am, parallel between the island of the Northeast area and the Southeast area through the LT 500 kV S. João do Piauí / Sobradinho, integrating the Northeast area to the SIN.

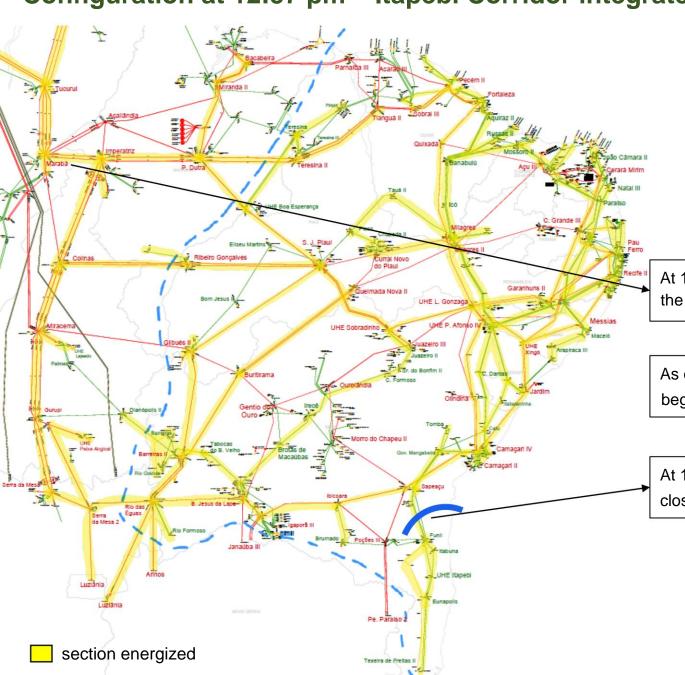
Machine Translated by Google Configuration at 12:57 pm – Itapebi Corridor integrated into the SIN

Service Conditions – 12:57 pm		
hydroelectric	3.638	
Wind	2.477	
photovoltaic	792	
Thermal	120	
FNESE – (NE -> SE)	-499	
FNEN – (NE -> N)	122	
NE load	7.404

At 12:01 am, the LT 500 kV Imperatriz / Marabá C2 was turned on, integrating the North area to the SIN.

At 12:56 pm, the LT 230 kV Santo Antônio de Jesus / Funil C2 was turned on, closing the Itapebi parallel with the SIN.

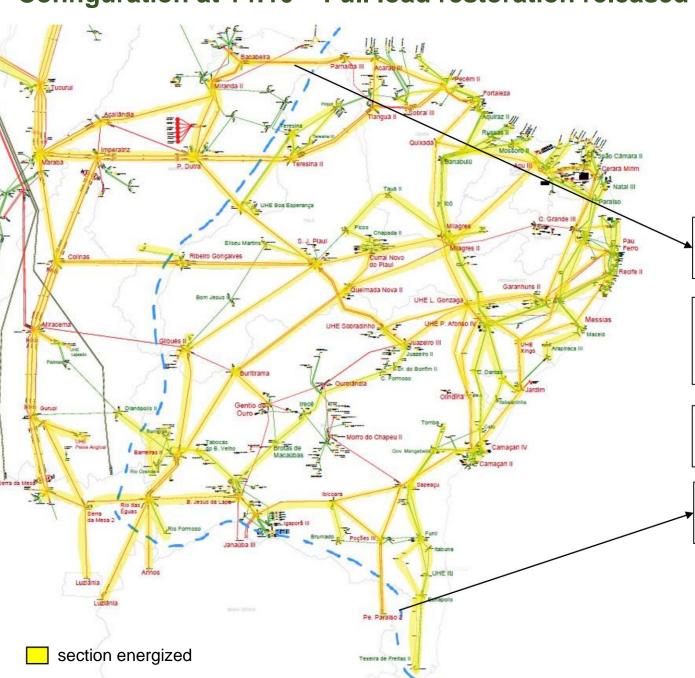
Machine Translated by Google Configuration at 14:10 — Full load restoration released

Service Conditions – 2:10 pm		
hydroelectric	3.779	
Wind	2.594	
photovoltaic	1.275	
Thermal	142	
FNESE – (NE -> SE)	-1.726	
FNEN – (NE -> N)	172	
NE load	9.344

At 2:02 pm, the LT 500 kV Bacabeira / Paranaíba III was turned on, reinforcing the interconnection between the North and Northeast systems

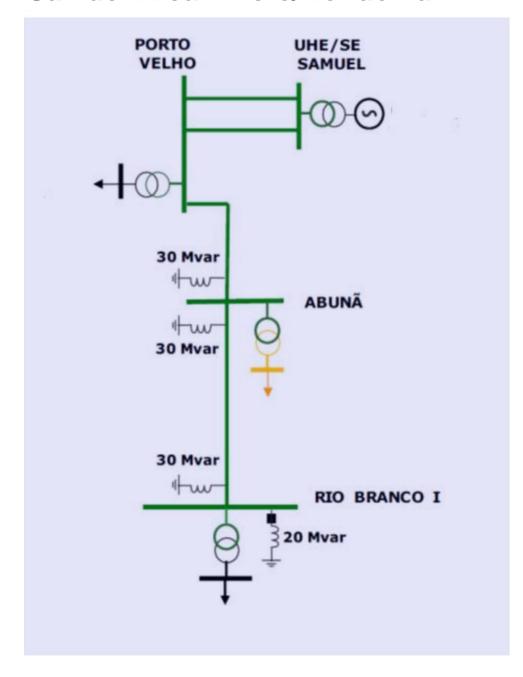
Samuel Area – Acre/Rondônia

Synchronism 1ª UG de Samuel	08:51
Home charging socket	09h18
Conclusion charging socket	11h42
Parallel	10h29

- Lack of substation preparation
- Need for recomposition coordinate.
